NASA/TM-2016-218973

# Finite Element Analysis and Test Results Comparison for the Hybrid Wing Body Center Section Test Article

*Adam Przekop, Dawn C. Jegley,  
Marshall Rouse, and Andrew E. Lovejoy  
Langley Research Center, Hampton, Virginia*

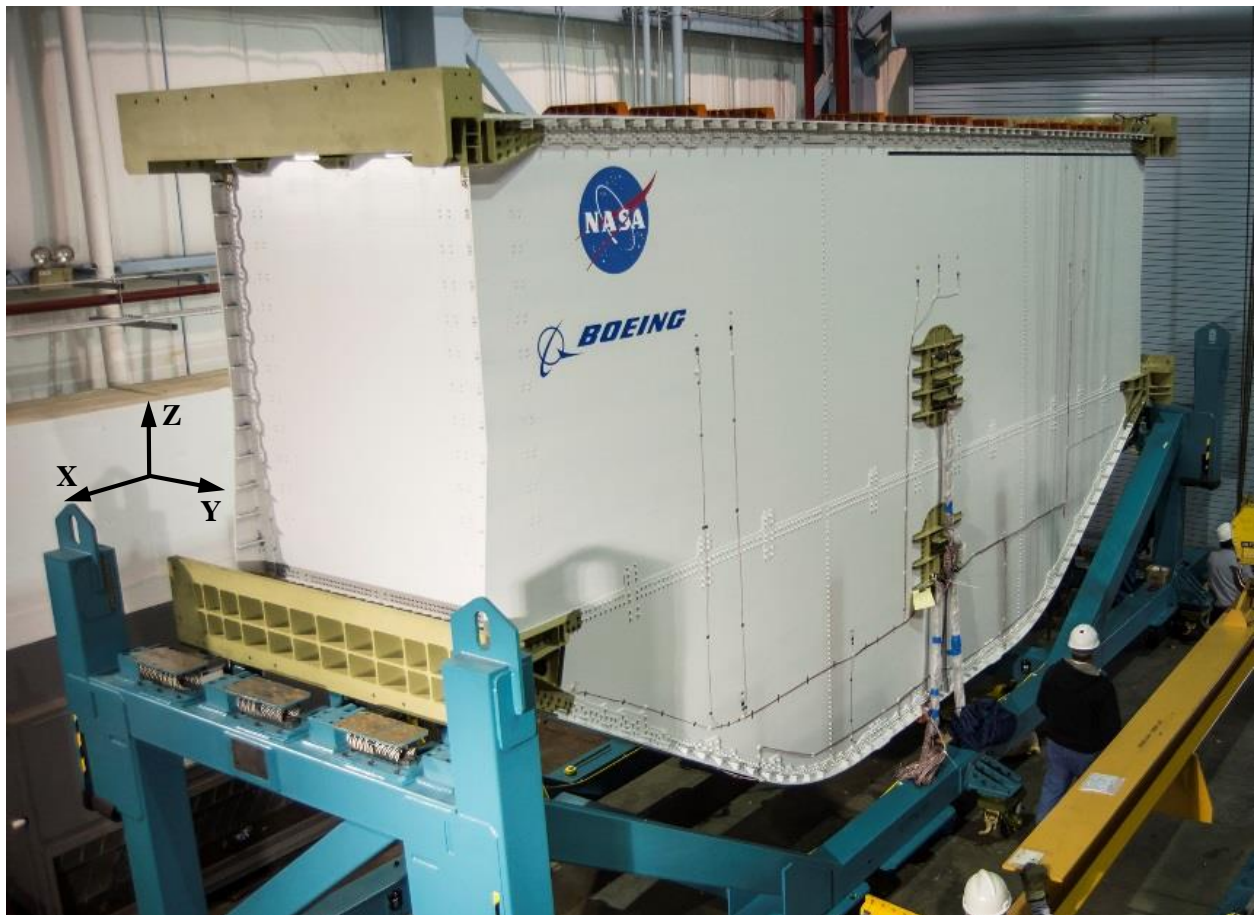
Figure 4. HWB center section test article in a transportation fixture.

The HWB center section test article is shown in Figures 3 and 4. The test article was approximately 30 ft. in span (along the X-axis, including the adaptor boxes shown in Figure 3), 14 ft. tall (along the Z-axis from the center keel to the crown panel), and 7 ft. wide (along the Y-axis between the bulkheads). The test article assembly comprised 11 PRSEUS panels and four sandwich panels. As shown in Figure 3, the 11 PRSEUS panels were: one crown, one floor, one center keel, two side keels (left and right), two upper bulkheads (forward and aft), two lower bulkheads (forward and aft), and two outer ribs (left and right). The four sandwich panels were two upper inner ribs and two lower inner ribs. All of the composite panels were mechanically joined at their edges by metallic fittings and fasteners.
